Manhole Inspection Summary

Manhole # S05YY1005MH

Insp Date: **9/25/06 1:34 PM**

Location Address: **3101 GLEN AVE**

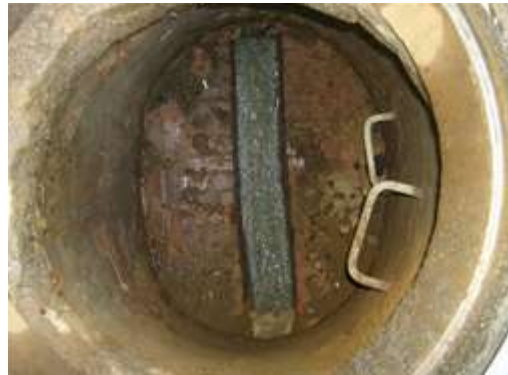
Top View

Frame Offset: **3** (in.) Condition: ☐ Sound ☐ Cracked ☒ **Leaks**

Infiltration: ☐ None ☒ **Joint** ☐ Cracks ☐ Mortar ☐ Roots ☒ **Wall**

Surcharge ☒ **Evidence Of Surcharge** Depth: **1** (ft.) ☐ Active Surcharge Present

Frame leaks. Adjustment infiltration.
Evidence of surcharge - Bench debris.

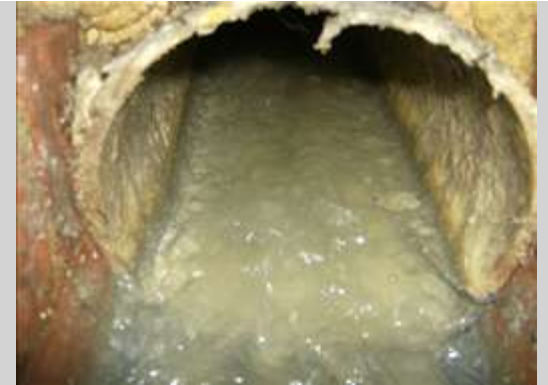
8 in. Circular Gravity Sewer Pipe Out @ 12 O'Clock

Invert Depth: **6.70** (ft.) Flow Characteristics: **Fast**

Deposits: ☒ None ☐ Mud ☐ Sludge ☐ Debris ☐ Grease

Infiltration: **None** Pipe Seal Cond: **Unknown**

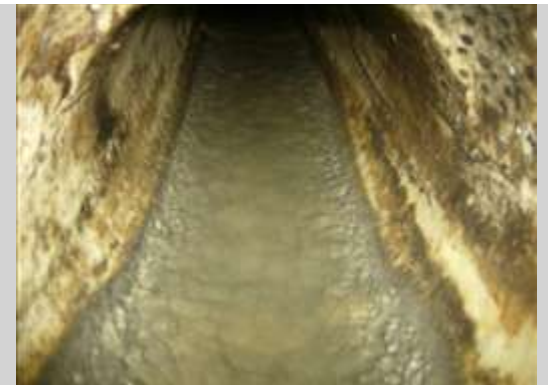
8 in. Circular Gravity Sewer Pipe In @ 6 O'Clock

Invert Depth: **6.52** (ft.) Flow Characteristics: **Fast**

Deposits: ☒ None ☐ Mud ☐ Sludge ☐ Debris ☐ Grease

Infiltration: **None** Pipe Seal Cond: **Unknown**
